Manhole Inspection Summary

Manhole # S41GG_006MH

Location Address: **SIDEOF 1221 CENTRAL AVE**

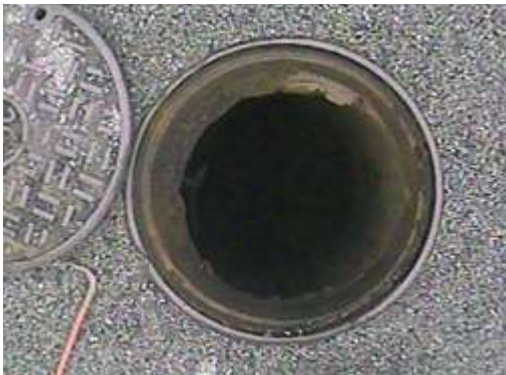
Defect 4

Offset: **2** (in.)

frame offset

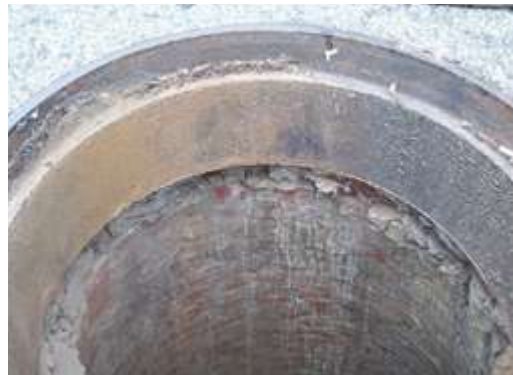
Defect 3

Condition: ☐ Sound ☒ **Cracked** ☐ Root Intrusion ☒ **Loose Brick** ☒ **Deteriorated**

chimney cracked, deterioration

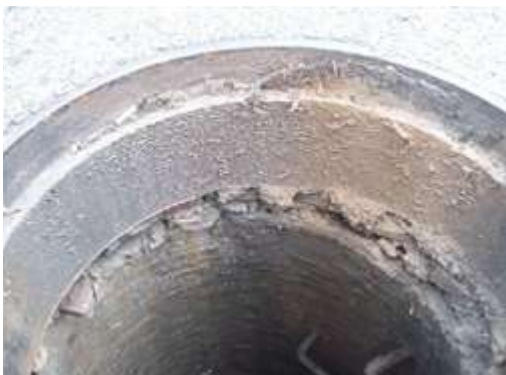
Defect 2

chimney loose bricks

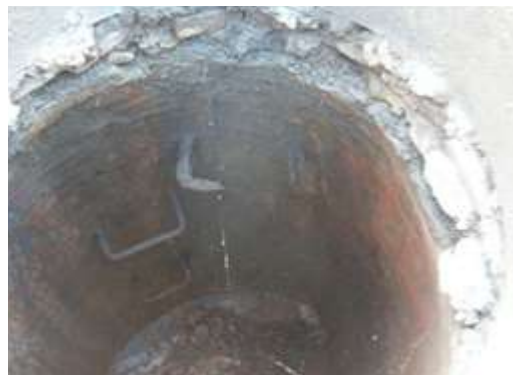
Defect 4

Count: **2** Missing: **3** ☒ **Corroded**

Corroded steps

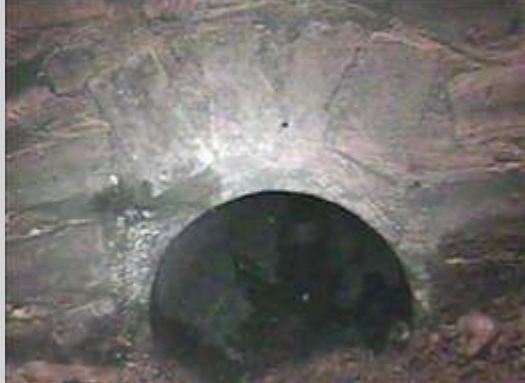
12 O'Clock Outflow

8 in. Circular Gravity Sewer
Pipe Out @ 12 O'Clock

Infiltration: **None** Pipe Seal Cond: **Sound**
